Forestry death

This bulletin provides information about a recent forestry death. Learning from accidents can help prevent future fatalities. WorkSafe thanks the family of the forestry worker for their support with sharing these details.

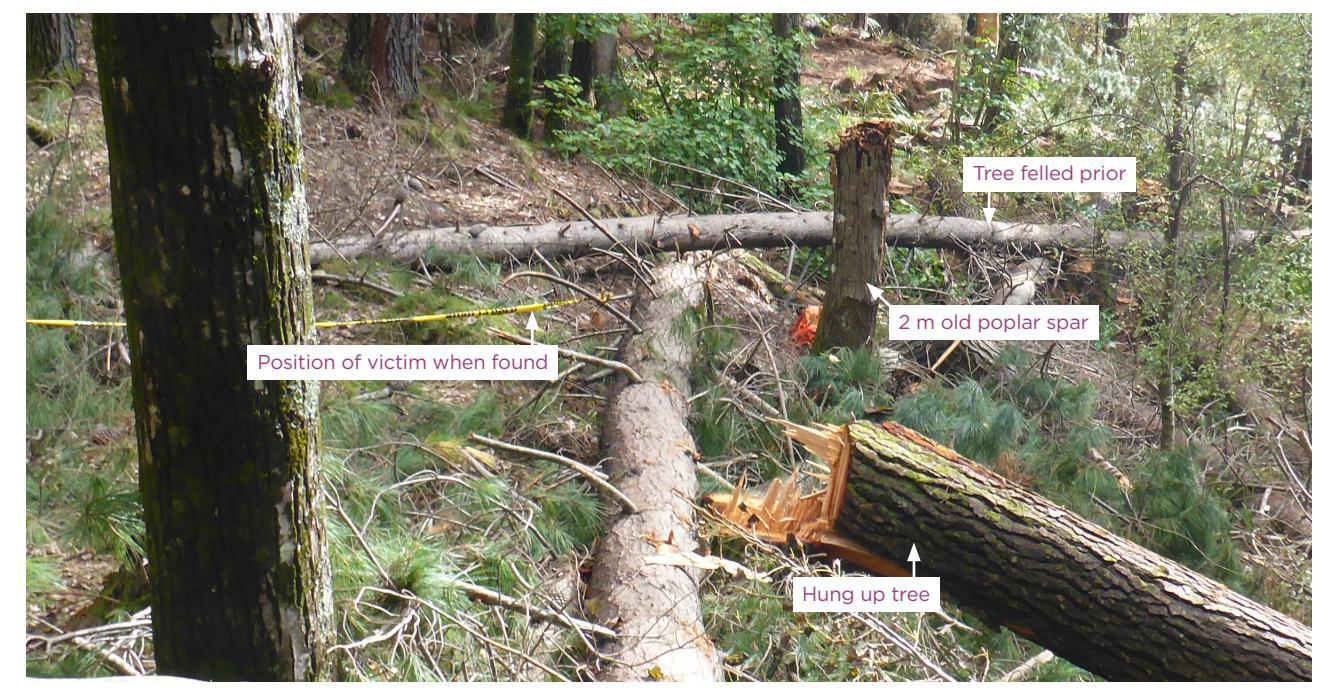
Figure 1 (below) shows the scene of the accident. The old poplar spar has caused the drive tree to 'Gimbal' (Seesaw) and kick backwards striking the victim.

FIGURE 1: Accident scene showing escape route blocked by a tree felled prior to falling the drive tree

The faller drove a tree to clear a hung up tree and in the process the driving tree has hit an old poplar stump/ spar and this has caused the tree to rebound back and strike the victim.

- the drive tree has hit the hung up tree without taking it to the ground
- the drive tree has slid down the right hand side and then struck a 2 m poplar spar (or stump) that was in direct line between the driving tree and hung up tree
- as the driving tree hit the spar it has caused the tree to pivot lifting the butt in the air
- forces from the tree hitting the hung up tree and the poplar stump have caused the butt of the tree to move backwards, approximately 1.8 m behind the stump of the driving tree and hit the victim
- the victim managed to radio for help.

The escape route was blocked by a previously felled tree.

Dead spars need to be removed before the faller begins work in the area.

Establishing escape routes are a critical part of felling technique.
