April 2018

## Log intrusion

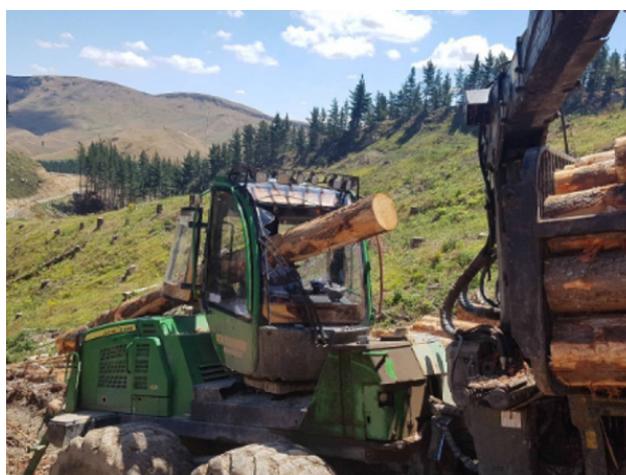
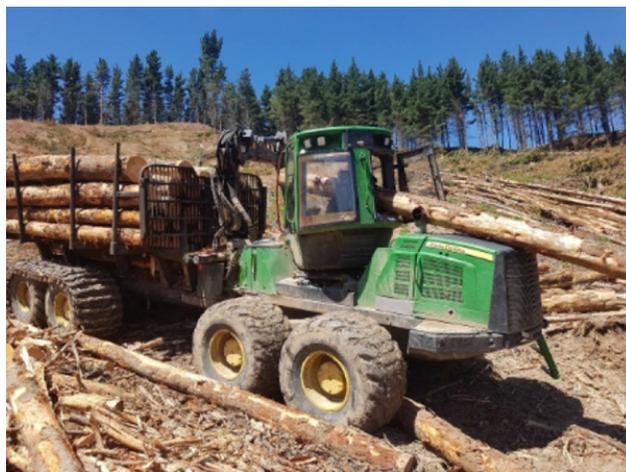
Earlier this year a 20-30 cm, 6 m, 400 kg log smashed through the 12 mm polycarbonate front and rear screens of a forwarder in the lower North Island. The operator was very fortunate to avoid almost certain serious injury.

In the interim we urge all operators to ensure that the steps being taken to protect operators from log intrusion are fully effective for the particular situation that the machine is being used in. These could include:

- ensuring you are using the right machinery for the job. This includes providing suppliers and certifiers with an accurate understanding of the task and situation you will be putting the machinery to use in
- ensuring that all manufacturer's instructions and recommendations are being followed
- reviewing if additional safeguards are need such as increased cab protection.
