## Poorly maintained tripod tanks are a safety risk

This safety alert highlights the serious health and safety risks that poorly maintained tripod tanks pose for fuel users and is from the Fuel Distributors Industry Safety Committee and Worksafe New Zealand.

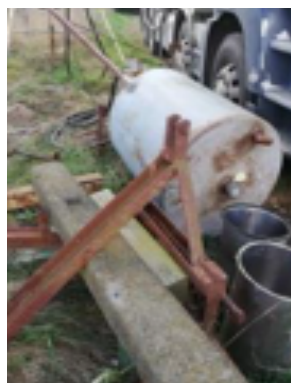
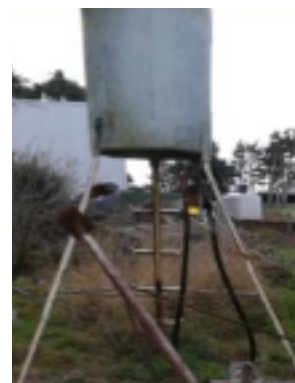
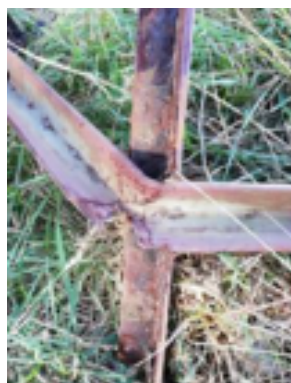
A fuel tanker driver was seriously injured in a recent incident on a farm in which a tripod overhead tank collapsed while he was filling it. The root cause of the collapse was significant corrosion (rust) on one of the tank legs – see examples below.

- check all your fuel tanks and support structures for signs of corrosion (rust) and metal fatigue and if there is rust or fatigue, consider tank replacement options
- make sure all tanks are properly secured to a flat foundation
- ensure the work area around each tank is safe, with a clear path free of obstacles.
