Extractives industry

2021/22 Q1

July to September

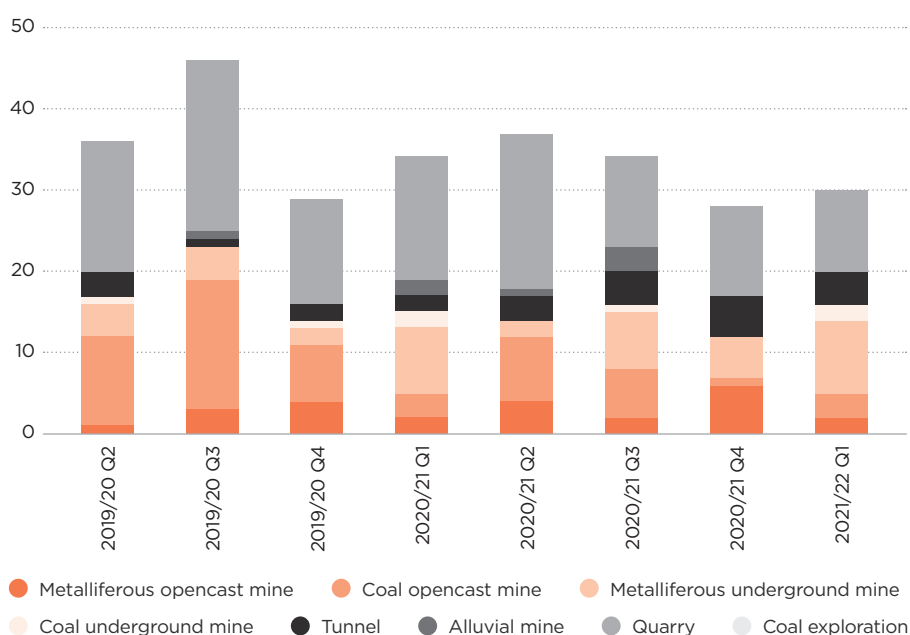
FIGURE 3:
Notifiable events
by sector

Figure 3 shows the number of notifiable events reported to WorkSafe by sector from October 2019 to September 2021.

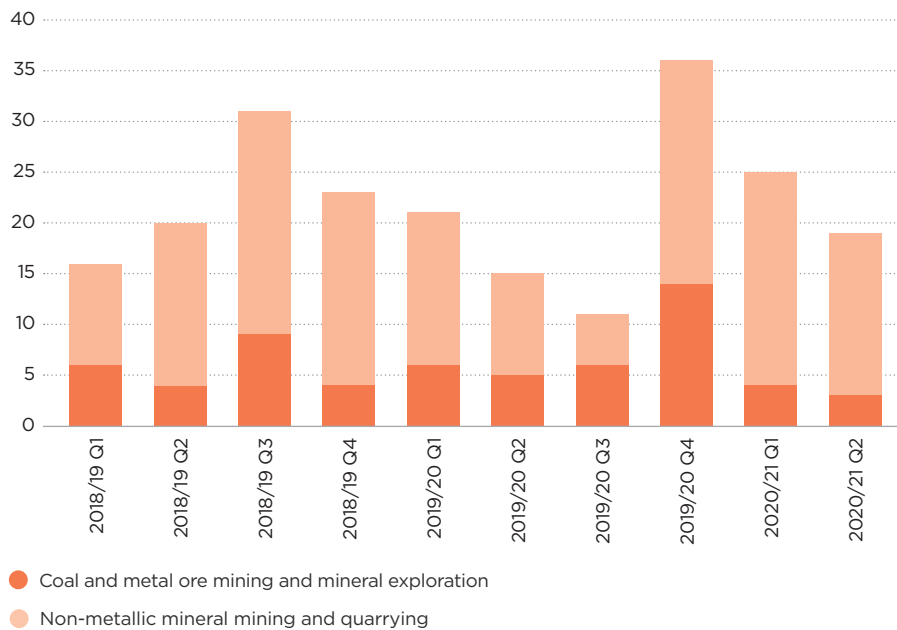
FIGURE 5:
Number of injuries resulting in more than a week away from work

Figures 5 and 6 show the number of injuries resulting in more than a week away from work (WAFW), and the sum of the claims costs for those WAFW injuries for the mining and quarrying sectors from September 2018 to March 2021. It is important to note that the number of WAFW injuries for previous quarters may increase over time as ACC can grant claims up to 12 months after an injury has occurred. The claims costs for WAFW injuries for previous quarters will also continue to increase over time as the true costs of those injuries are realised. It may take two years or more for the true costs to be realised. The average cost of extractives sector WAFW injuries between September 2018 and March 2021 was over \$19,000 per injury.

The data for these graphs comes from our System for Work-related Injury Forecasting and Targeting (SWIFT) database. It includes ACC data on approved work-related injury claims that resulted in more than a week away from work (WAFW). There is a seven month lag applied to the data to allow time for the claim information to stabilise, so data for the past two quarters is not yet available. While SWIFT data draws on ACC data, differences in counting criteria mean it may not match ACC counts, and should not be considered official ACC data.

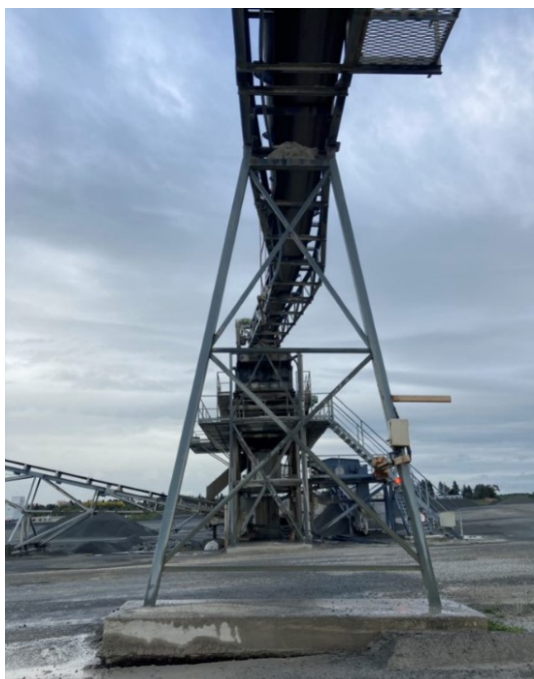
FIGURE 12:
Incident scene
photograph

INCIDENT DATE	SUMMARY	CONSIDERATIONS
Sep 21	Quarry truck operating on normal quarry roads travelled with the bin raised, which struck an overhead conveyor damaging both the conveyor and truck.	<ul style="list-style-type: none"> - Roads and operating surfaces - Job planning - Risk assessment - Supervision - Training

The truck was in good working order, and the prestart had been completed, although it was noted during Level 4 that the fitted deck alarm had stopped working. The alarm is audible outside of the cab; the purpose of the fitted alarm was to warn people in the vicinity that the truck was tipping off. A decision was made to continue using the vehicle, as it was assessed as low risk by the Quarry Manager because:

This incident and investigation report is very typical of what we receive. It is very apparent that this incident occurred as a direct result of a mobile plant operator error - failure to lower the tray, and which may have included some breach of rules around the taking of phone calls while operating equipment. Many would think that those factors alone were the most significant contributors to the incident, that the operator was the only problem.

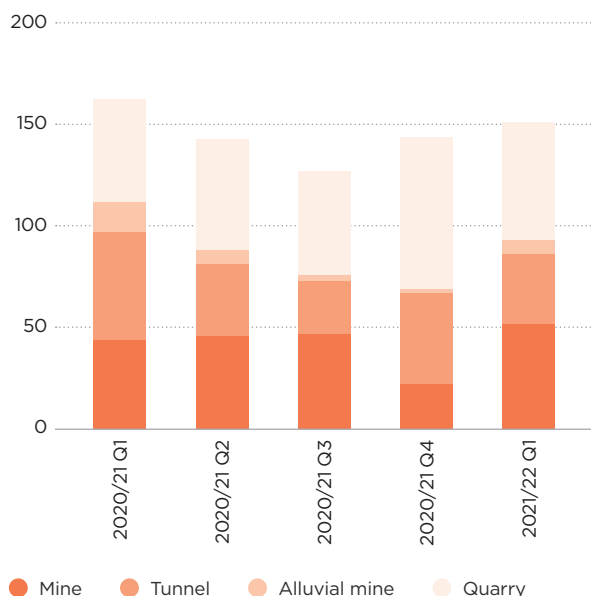
FIGURE 14:
Assesments by sector

Figure 14 shows the number of assessments undertaken by the regulator in Q1 2021/22 by sector. This quarter, 38% of our assessments were for quarries, 34% for mines, 38% for tunnels and 5% for alluvial mines.

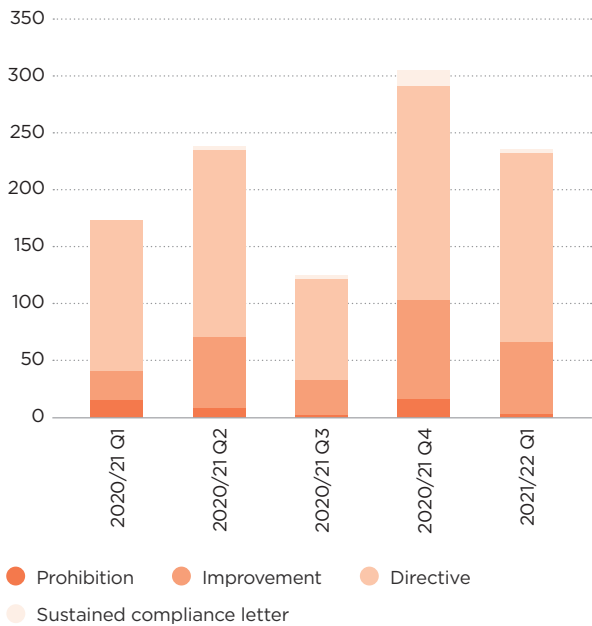
FIGURE 15:
Enforcement actions issued by type

Figures 15 and 16 show the number of enforcement actions issued in Q1 2021/22 by notice type and by sector. This quarter, a total of 236 enforcement actions were issued. Of those, 1% of were prohibition notices, 27% were improvement notices, 70% were directives and 1% were sustained compliance letters. The majority of the enforcement actions were issued to the mining (25%) and quarrying (51%) sectors.
